# EXPERIMENTS AND TARGET-GAS STORAGE AT THE CEA AT THE TIME OF THE JULY 5, 1965 ACCIDENT AND FIRE\*

R. D. Biron

*Massachusetts Institute of Technology  
Cambridge, Massachusetts*

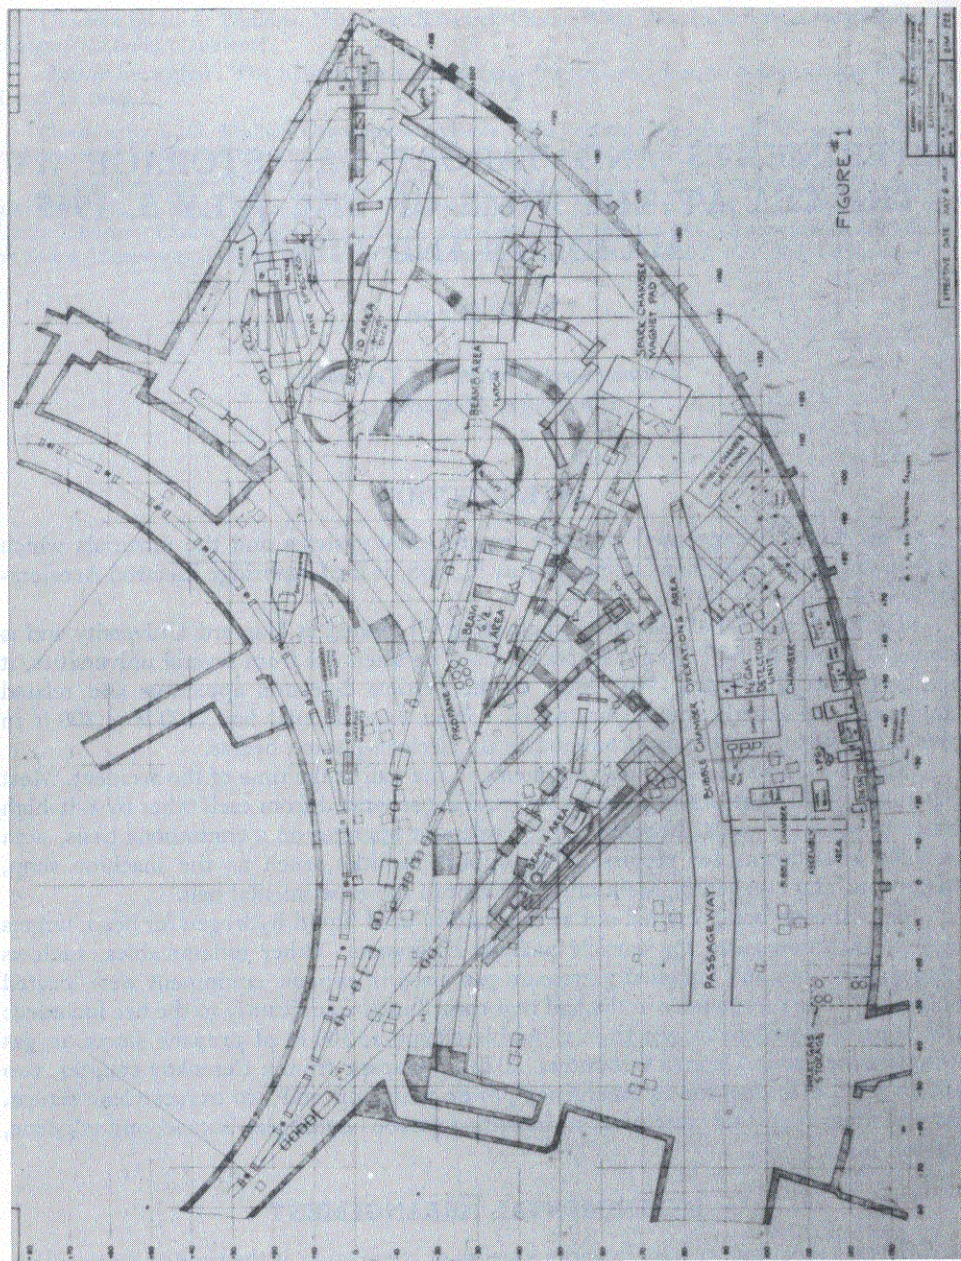
Fig. 1. Experimental floor.

Figure 1 shows the various experiments in the hall at the time of the accident. Most experiments are located along beam paths and are separated from each other by 8-ft-high concrete radiation walls. Normally, the accelerator operates on a continuous basis, with periodic shut-downs for repairs. The support facilities, such as the machine shop, electronics, and cryogenics, are located adjacent to the experimental hall.

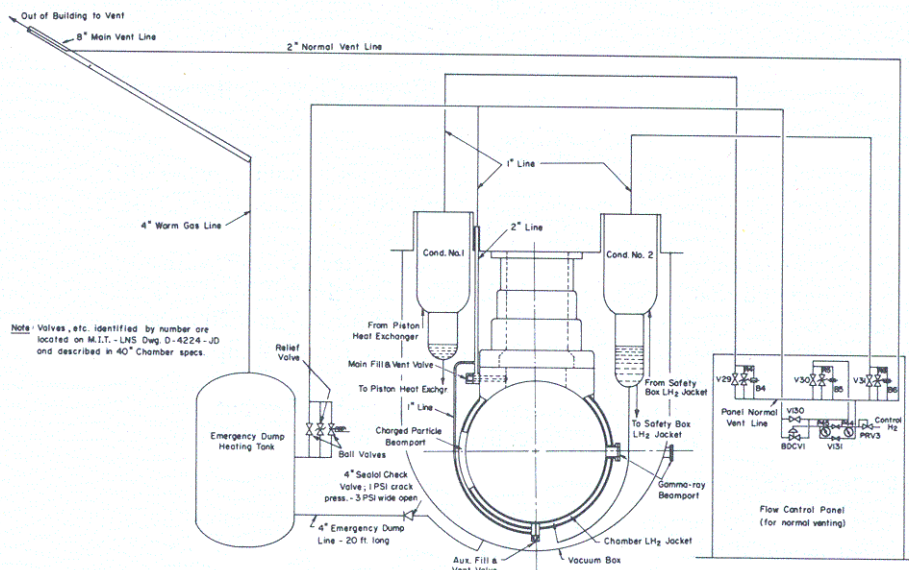
Fig. 2. Bubble chamber dumping and venting systems.

Several means of venting the bubble-chamber system were provided, as shown in Fig. 2. All dump and vent valves were connected to either a normal vent or an emergency vent. The normal vent line extended directly to the out-of-doors, and the emergency dump line was connected to an emergency dump tank. This vessel contained several tons of copper shot that would provide sufficient heat capacity and heat-transfer surface to warm the hydrogen prior to being dumped outside. The exhausting hydrogen was of sufficiently low density to ensure rapid diffusion in the air. A hydrogen-detection system monitored conditions in the bubble chamber area.

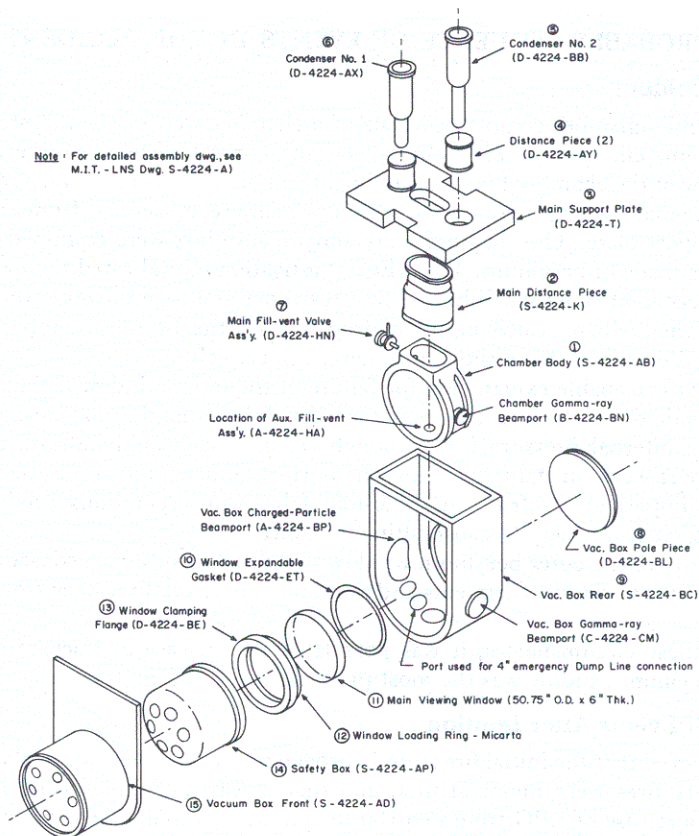
Fig. 3. General expanded view of 40-in. bubble chamber, showing order of assembly of major components exclusive of expansion system.

The bubble-chamber complex consists of a chamber, refrigeration system, magnet, vacuum system, emergency vent system, and the control system. Figure 3 shows an exploded view of the chamber body, safety box, main viewing window, vacuum box, main distance piece and hydrogen condensers, all of which are suspended from and sealed to the main support plate. The chamber body and vacuum box were equipped with beamport windows made of beryllium. The AEC investigation [1] indicated the most probable cause of the accident to be the failure of first the inner and then the outer of these beryllium beamports, which sealed liquid hydrogen from the bubble-chamber insulating-vacuum and the vacuum from the atmosphere, respectively.

The most reasonable explanation for failure of the inner window is that it fractured in a brittle mode due to biaxial stresses induced by differential thermal contraction forces as well as by internal pressure [3]. Although calculations would indicate that stresses in the beamport were substantially below the normal failure levels, it has been suggested that surface imperfections from machine-tool fabrication operations produced stress-raisers of sufficient intensity to cause ultimate failure.

The failure of the outer beryllium window was concluded to be a consequence of the impact of the inner-window fragments and the sudden temperature shock from the hydrogen.

Under these circumstances, it was postulated that release of fracture energy from the outer beryllium window was the most probable source of ignition.
